FRP RETROFIT OF WALLS CONSTRUCTED WITH HISTORICAL BRICKS

Keywords: Brick, FRP, Historical, Masonry, Retrofit, Seismic.

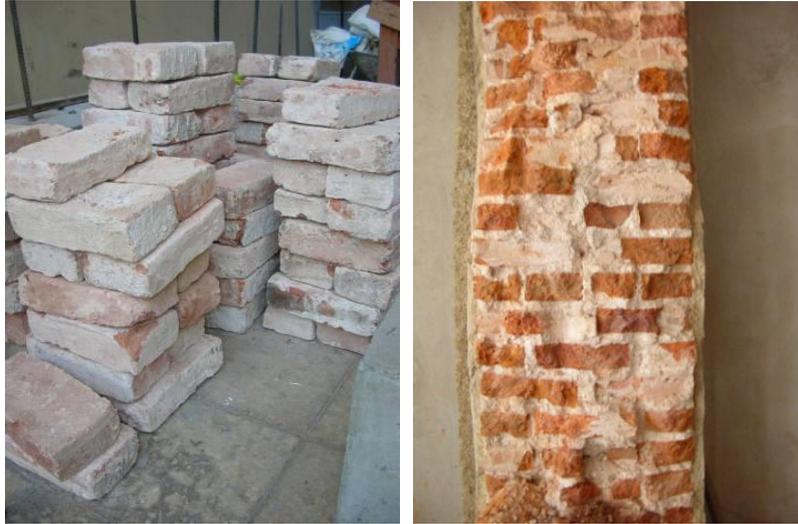
Figure 3: Historical bricks

The clay bricks, which were used during preparation of wall specimens, were collected from a historical building, which is around 130 years old, (Fig. 3). The dimensions of the bricks were approximately $60 \times 110 \times 230 \text{ mm}^3$. Before using as wall units, they were cleaned thoroughly and made free of mortar. The average compressive strength and elasticity modulus of these bricks were determined as 5.0 and 118 MPa at the end of single brick compression tests. These mechanical characteristics were determined as 2.1 and 192 MPa at the end of compression tests of prism specimens of three bricks.

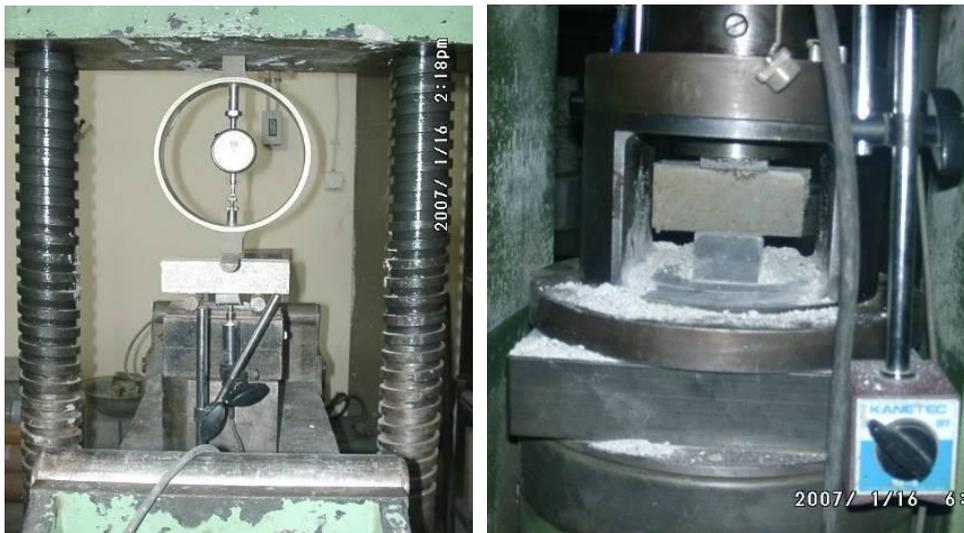
Figure 4: Tests for determination of mechanical characteristics of joint mortar

For determining the appropriate joint mortar, which can represent the mortar characteristics in-situ, 6 different trial mixtures were prepared. All trial mixtures were composed of cement, hydraulic lime, sand and water. At the end, a mixture of cement, hydraulic lime, sand and water, with the respective ratios of 01: 02: 15: 2.6, by weight was shown to represent the existing mechanical characteristics of existing joint mortar in the historical building. The mechanical characteristics of original joint mortar and trial mortar mixtures were determined through three point bending tests and compression tests (Fig. 4). After these tests, average flexural tensile and compressive strengths of the joint mortar used in the construction of wall specimens were determined as 1.2 and 3.3 MPa at 28 days and 1.6 and 3.8 MPa at 90 days.

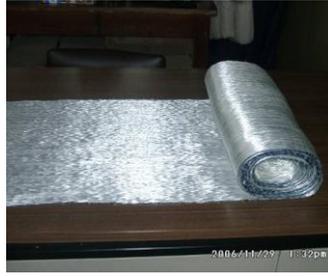
Figure 5: Glass FRP sheets to be used for retrofit of walls

For retrofitting, EG-60AR glass FRP, with the elasticity modulus of 65.000 MPa and tensile strength of 1700 MPa was used, (Fig. 5). The effective thickness and maximum elongation of the material was given as 0.23 mm and 2.8% by the manufacturer. The glass FRP sheets were bonded on the plaster using an epoxy based adhesive, with the tensile elasticity modulus of 3000 MPa and tensile strength of 50 MPa.

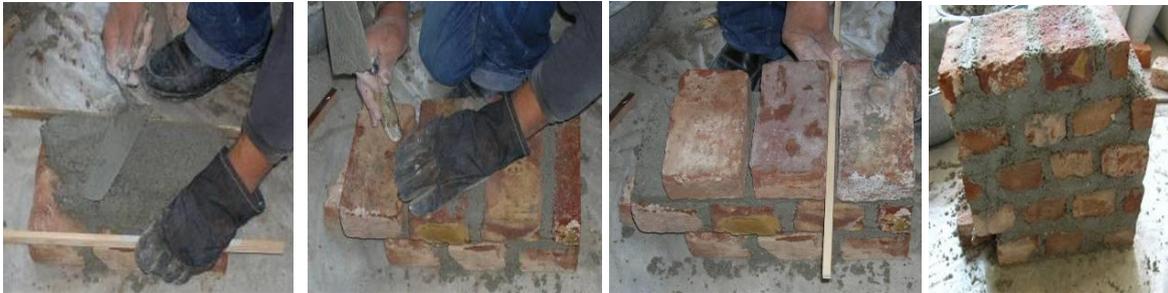
Figure 6: Construction of wall specimens

The dimensions of specimens were approximately $500 \times 500 \times 230 \text{ mm}^3$. While constructing the specimens, a special mortar mixture was used for the mortar to represent the mechanical characteristics of the mortar used in this historical building. The thicknesses of horizontal and vertical joint mortar were 20 and 10 mm, respectively. The construction phases of wall specimens are presented in Fig. 6. After walls were constructed, the surfaces of the specimens other than the reference specimen were covered with plaster of repair mortar, (Fig. 7). The thickness of the plaster was approximately 20 mm on both surfaces. After plastering, three specimens were retrofitted by bonding the glass FRP composites on two surfaces, (Fig. 8). Specimen C-1, C-2 and D were strengthened with one, two and two plies of glass FRP sheets on both surfaces, respectively. The application of glass FRP anchors into the bricks is presented in Fig. 9.

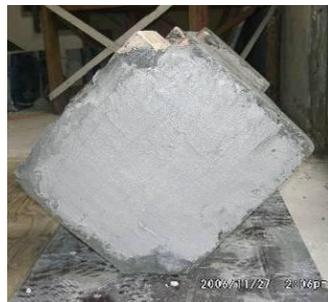
Figure 7: Plastered specimen

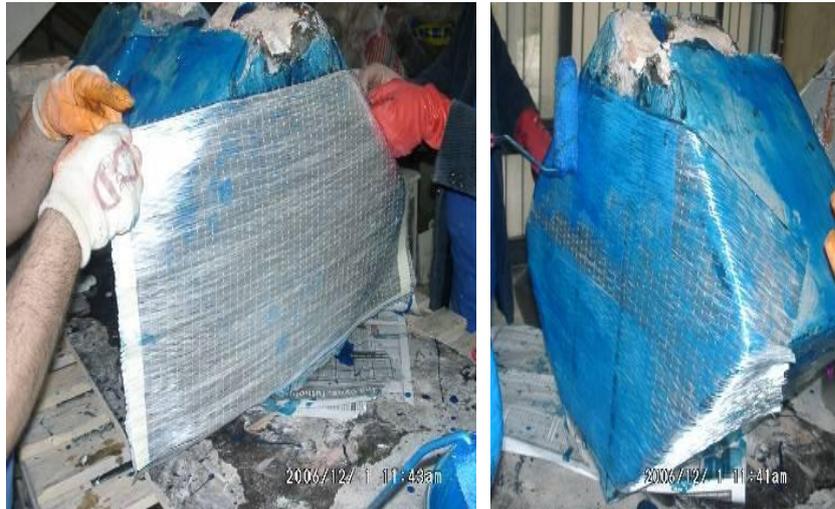
Figure 8: FRP application on specimens C-1 and C-2

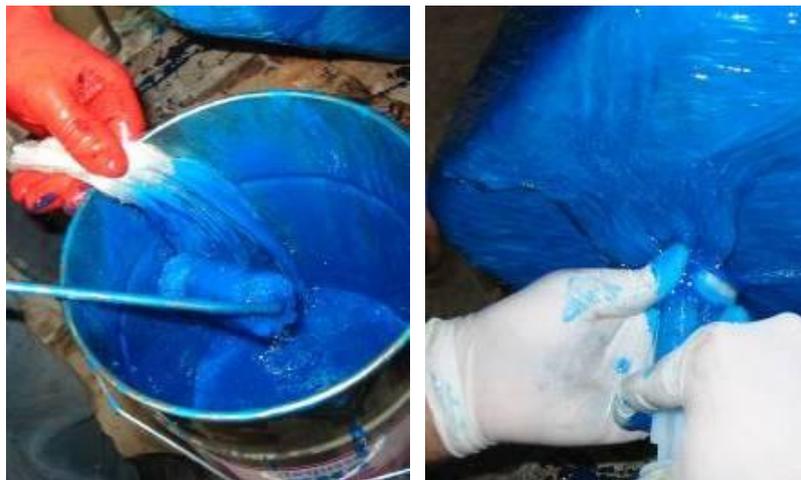
Figure 9: Application of glass FRP anchors into the retrofitted specimen D

Specimen D, which was identical to specimen C-2 with additional glass FRP anchors as shown in Fig. 2 and Fig. 9, failed in a similar manner as specimens C-1 and C-2 with two slight differences, which were provided by the additional anchors, Fig. 15. The separation of FRP sheet, plaster and a thin surface of brick wall initiated at around 60 kN load and average vertical strain of 2000 microstrain. However, in contrast to other specimens, the separation did not cause a sudden and significant drop in strength, but a small reduction in the resisted load, followed by an increase in the capacity up to 63 kN at up to the average vertical axial strain level of 3000 microstrain. After this point, the resisted load decreased gradually, exhibiting a better ductility than the other FRP retrofitted specimens.

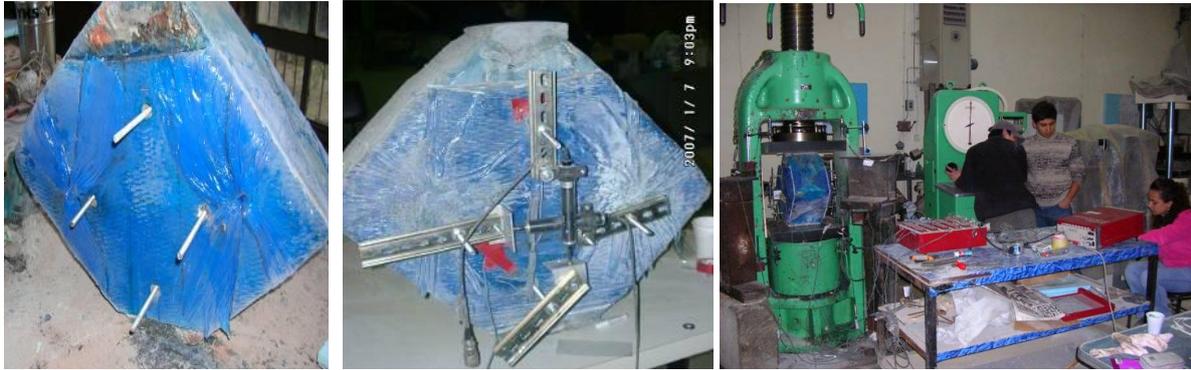
Figure 10: Testing setup

All the specimens were tested under diagonal tension using an Amsler Loading Machine. The average longitudinal and transverse deformations were measured on both surfaces of specimens by using displacement transducers and strain gages. The average longitudinal deformations were measured in the gage lengths of 270 and 500 mm by using displacement transducers and in the gage length of 60 mm by strain gages. The average transverse deformations were measured in the gage length of 250 mm by displacement transducers and in the gage length of 60 mm by strain gages. All data was collected by a data logger through a switch box. The testing setup is shown in Fig. 10.

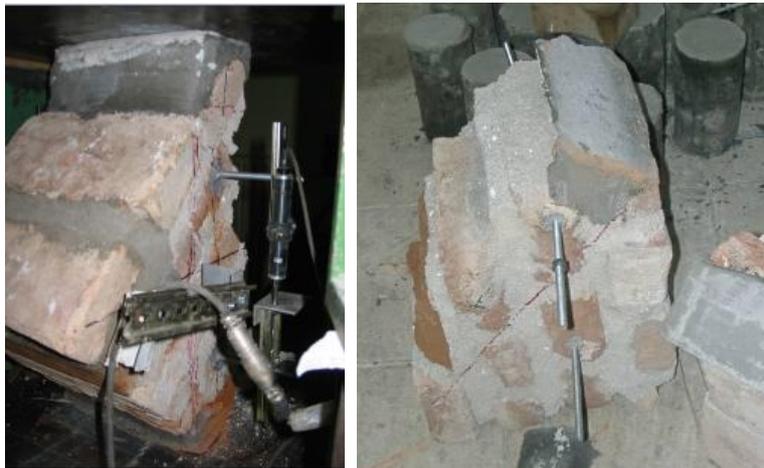
Figure 11: Damage of reference specimen A

The reference specimen A failed in a brittle manner at a very low level shear stress due to vertical separation of wall into two parts. The separation followed the boundaries of horizontal and vertical mortar joints and brick units had minor breakages. The maximum load and load corresponding to vertical crack formation were almost same. Vertical deformation was slightly higher at maximum load with respect to load at which vertical crack was formed. No compression failure of bricks or joint mortar was observed throughout the loading.

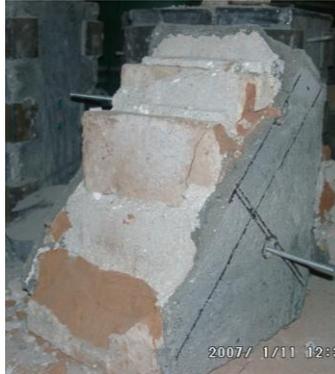
Figure 12: Damage of plastered specimen B

Specimen B with plaster on two surfaces also failed due to a vertical crack similar as specimen A, passing through the interface between bricks and joint mortar, with minor damage to brick units around the crack. However, the behavior was remarkably better in terms of both ductility and strength. The damage of specimen B is presented in Fig. 12.

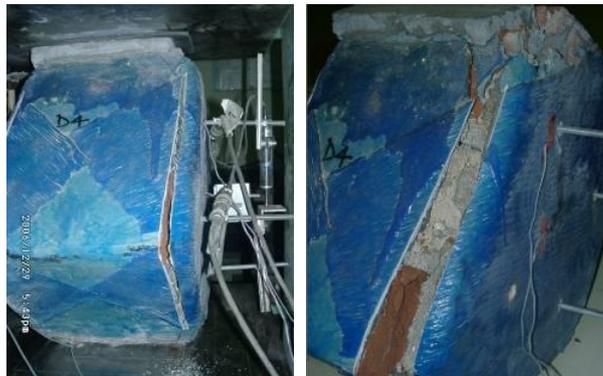
Figure 13: Damage of FRP retrofitted specimen C-1

Specimen C-1 retrofitted with 1 ply of glass FRP sheets on two surfaces over plaster failed suddenly due to separation of FRP sheets, plaster and a thin layer of bricks from the brick wall. The failure phenomena showed that the weakest link was the brick itself. The resisted load by this specimen, as well as the average vertical deformation at peak load, were more than three times those of reference specimen and more than two times than those of the specimen with plaster. Although the failure occurred at a significantly higher deformation level, ductility was poor due to sudden loss of strength caused by peeling off the brick surface together with the plaster and glass FRP sheet on one surface of the specimen. After the test, it was observed that there was a vertical crack under the plaster and FRP sheet, which continued along the vertical and horizontal joint mortar. At the peak load, there were indications of local brick crushing around the loading points, while there was no crushing at the middle parts of the specimen.

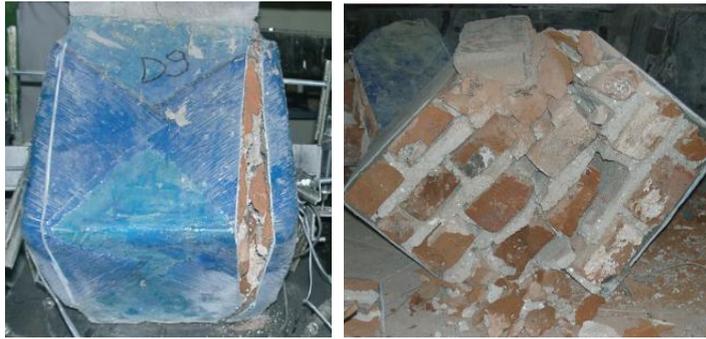
Figure 14: Damage of FRP retrofitted specimen C-2

Failure mechanism of specimen C-2 was similar as specimen C-1, Fig. 14. Since the tensile strength of bricks, whose average flexural tensile strength was defined as 1.4 MPa, was the weakest component, glass FRP sheets were never stressed near their tensile capacities. Therefore, increase in the thickness of FRP sheets did not positively affect the behavior. The capacity of this specimen was less than that of specimen C-1, while their deformability characteristics were similar. The difference in strengths of specimens C-1 and C-2 is attributed to the variation of brick quality, since the bricks were original 130 years old bricks, which were collected randomly. Unlike the reference (A) and plastered (B) specimens, whose capacities were governed by the strength of joint mortar, the capacities of these two specimens were governed by the tensile characteristics of bricks.

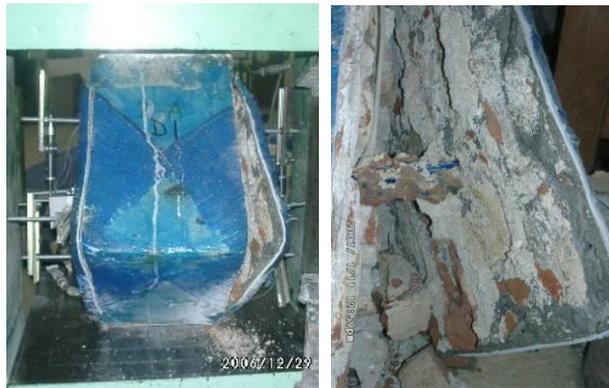
Figure 15: Damage of FRP retrofitted specimen D with FRP anchors
