STRUCTURE INSPECTING AND MONITORING OF SUSPENSION BRIDGES

A dynamics-based methodology and inspecting technologies for the structural evaluation of historic structures was applied to the Bitan suspension footbridge (Figure 1). Getting realize the dynamics characteristic of historic structures to build up standards for future maintenance.

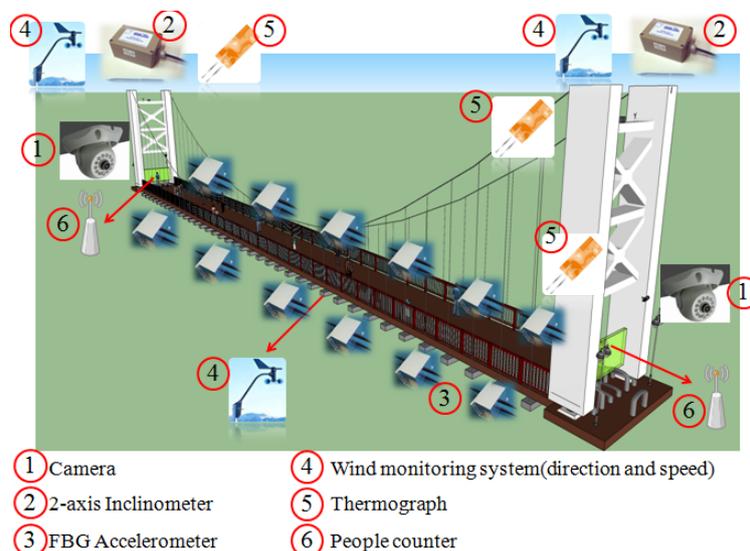
Figure 2. Structure health monitoring of footbridge

Structure monitoring system constructing scheme involves a 2-axis inclinometers, concrete and cable thermograph, and wind monitor system on the top of the pylon. Structure vibration tests were conducted on the bridge using a 4-channel data optical fiber acquisition system with a total of 12 2D/3D FBG accelerometers installed on the lateral sides of the bridge. 2 sets of 3D FBG accelerometers are installed near the center of the bridge (Figure 2).

Human beings calculating system was set on the east and west entrance of the footbridge. And the number of people will deliver to the local working station nearby the footbridge. There is a LED electron bulletin provide safety guard to execute restrain when the tolerance capacity exceed. With camera also installing on both pylon, it can provide field situation to get further information.
